Building Inspection Report

129 North A St Lompoc, CA , 93436

Inspection Date:

05/10/2011

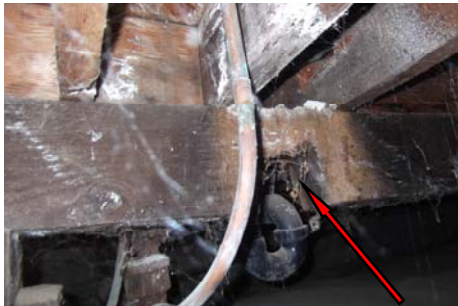
Notching in Girder

- **Repair:** Notching was observed in girder and floor joist in crawl space. It is beyond the scope of this inspection to speculate the load capabilities of damaged girder. This condition risks structural movement and damage. Recommend further evaluation by a qualified building contractor and repair as needed.
- **Repair:** The floor structure shows evidence of rot under kitchen and bathroom. Rot weakens the structure and causes distress to the building. Damaged wood should be repaired or replaced and the conditions that have promoted the rot (such as wet conditions and/or poor ventilation) should be remedied. Recommend further evaluation by a qualified plumber and general contractor.

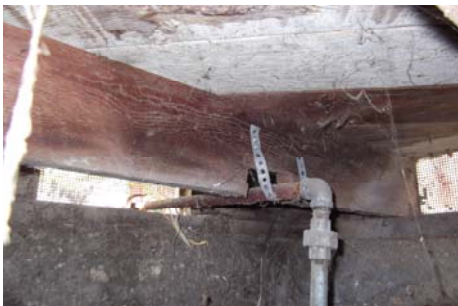
Notch in Floor Joist

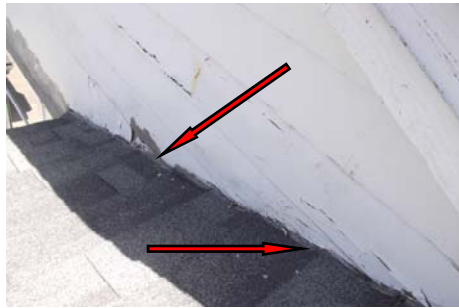
Missing Flashing

- **Repair:** The roof to wall flashing's are missing on the east side of house. Recommend further evaluation of all flashing by a qualified roofing contractor.

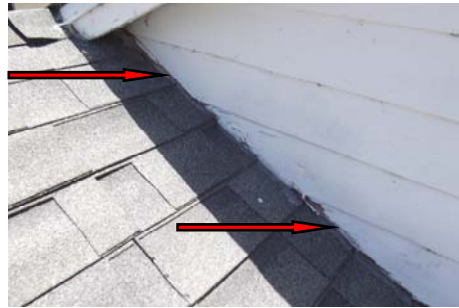
Missing Flashing

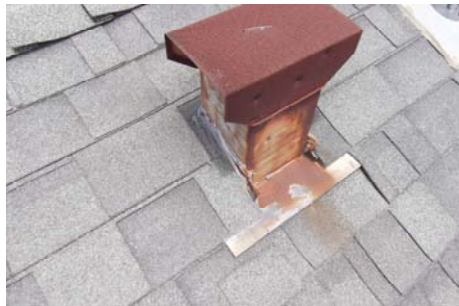
Rusted Abandoned Exhaust Vent

- **Monitor:** The flashing around chimney is improper, vulnerable and should be carefully monitored for leaks.
- **Repair:** The abandoned kitchen hood vent flashing is rusting. It should be painted or removed.

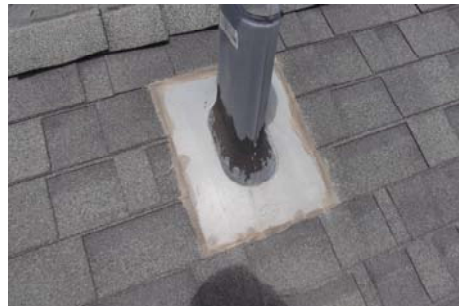
Improper Flashing

- **Repair:** Improper installation of flashing was observed at both shed roof location on west side of house. Counter flashing should be installed in this location. Although no active leaks were observed we recommend keeping flashing sealed and maintained with an approved material. Recommend further evaluation by a qualified roofing contractor if moisture intrusion is observed at a later date.

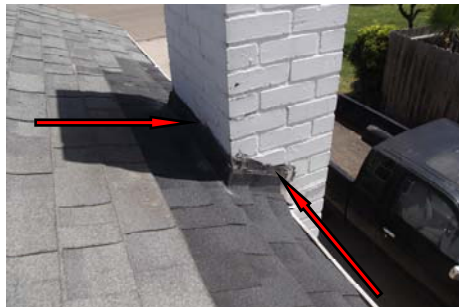
Improper Flashing

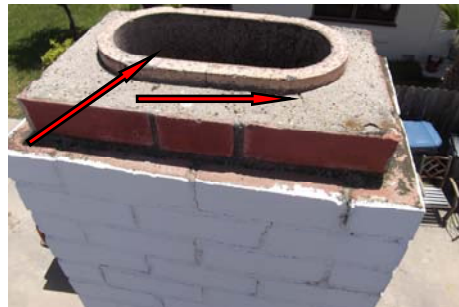
**Cracked Crown and Flue Liner,
Missing Spark Arrester and Cap**

- **Repair, Safety Issue:** The masonry chimney should have a Level 2 inspection performed by a FIRE certified inspector prior to operating.
- **Repair:** The chimney crown or wash is cracked and should be sealed to avoid moisture intrusion to the chimney assembly. Water intrusion can lead to property damage and failure of chimney. Recommend sealing and maintaining cracks in this area. Cracked flue liner was observed at top of chimney Refer to above (Inspect) comment

- **Repair:** A rain cap and vermin screen should be installed on the masonry chimney and the chimney flue should be checked for damage. Damaged flues can be unsafe.

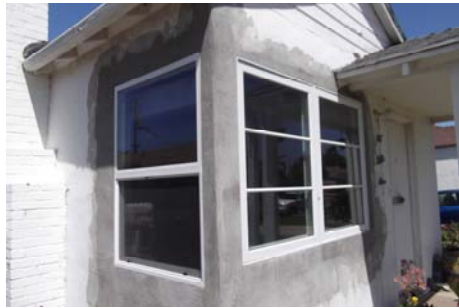
Repair Evident, Monitor For Leaks

- **Monitor:** Repair's evident on the south east corner window. Recommend finish paint and monitoring for leaks.

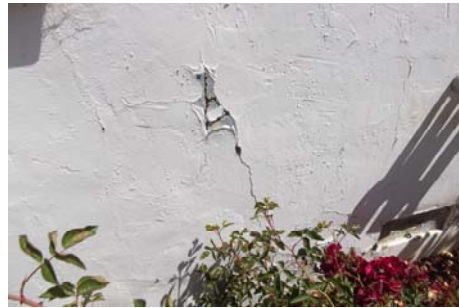
Cracks In Stucco

- **Repair:** Localized damage of the stucco exterior walls (staining and or cracks) should be repaired. There is extra risk of hidden damage in such areas caused by previous or present leaks that should be sealed.
- **Repair:** The exterior stucco surfaces should be painted at window repair south east corner around the house.
- **Repair:** The wood siding material is deteriorating on house and garage. Localized repairs, replacement and/or painting may extend the life of the siding. Wholesale replacement may eventually be necessary – a significant expense which can be deferred when only limited areas of damage are found.

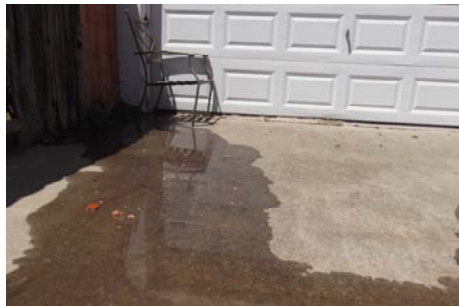
Drainage Toward Garage

- **Possible Major Concern, Monitor:** The driveway appears to slope towards the garage. This condition can cause water entry in the building. Unfortunately, it is difficult to improve this situation without resurfacing the driveway adjacent to the foundation or by adding a special intercept drain system at the garage entry.

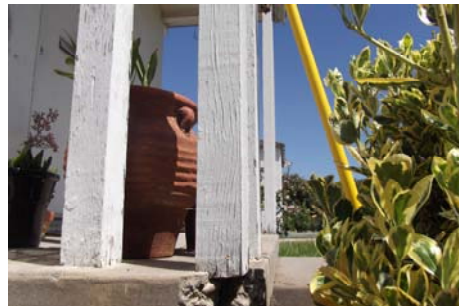
Deteriorated Concrete Under Support

- **Repair:** The concrete under front porch cover is deteriorated underneath support post. It should be repaired or replaced by a qualified building contractor as necessary.

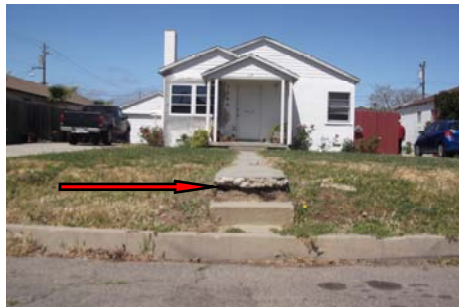
Trip Hazard

- **Repair, Safety Issue:** The concrete steps near street are deteriorated and present a trip hazard. Hand rail should also be provided for added safety. This condition should be altered by a qualified concrete and general contractor.

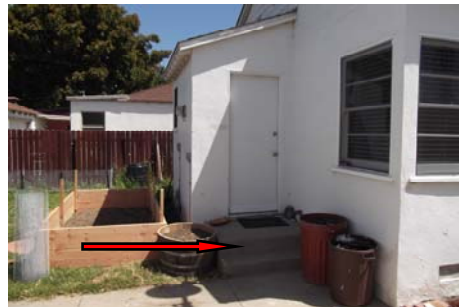
Step Risers Different Size, Trip Hazard

- **Repair, Safety Issue:** The back porch stair risers are different heights and represent a trip hazard. This is a safety concern that should be addressed promptly. Recommend engaging a qualified building contractor to repair condition(s) noted.

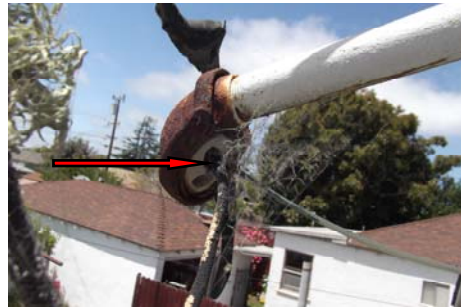
Frayed Service Wires

- **Major Concern, Repair:** The electrical service is outdated and undersized. It should be upgraded by a qualified electrician to at least 100 amps.
- **Repair:** Damaged or frayed service wires at weather head should be repaired or replaced as needed.

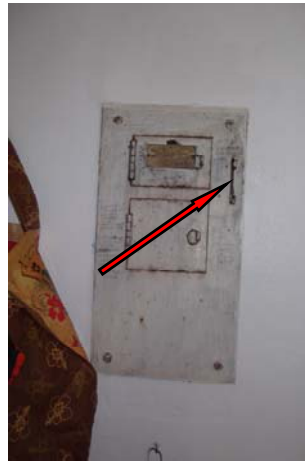
Unable To Remove Cover

- **FYI:** Main Panel cover could not be removed without moving main disconnect to the off position. Main Panel was not inspected. Recommend a full evaluation of the electrical system by a qualified electrical contractor.
- **Repair:** Oversized fuses within the main distribution panel should be replaced. All fuses serving household branch circuits were observed to be 30 amps. This presents a possible overload of branch circuits and should be corrected by a qualified electrical contractor.

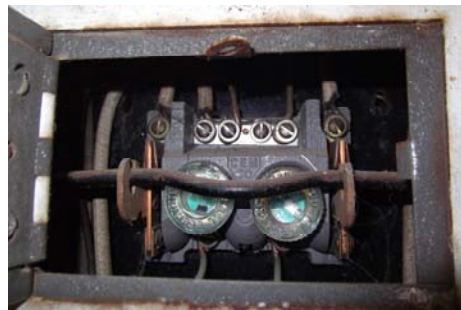
30 Amp Main Fuses

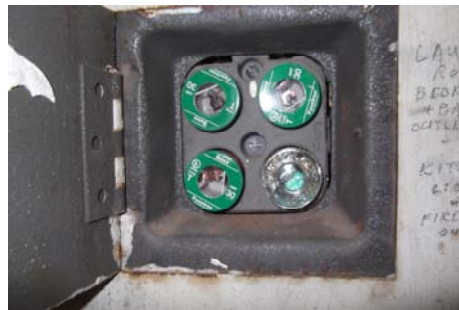
Oversized Fuses

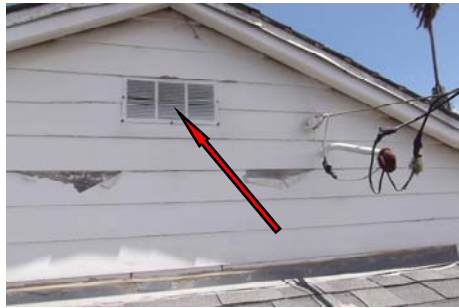
Only Attic Vent

- **Monitor:** Attic area was not inspected due to occupant's belongings blocking access.
- **Repair:** The level of ventilation should be improved over house. It is generally recommended that one (1) square foot of free vent area be provided for every one hundred and fifty (150) square feet of ceiling area. Proper ventilation will help to keep the house cooler during warm weather and extend the life of roofing materials. In cold climates, it will help reduce the potential for condensation within the attic. Recommend engaging a qualified roofing or general contractor to repair condition(s) noted.

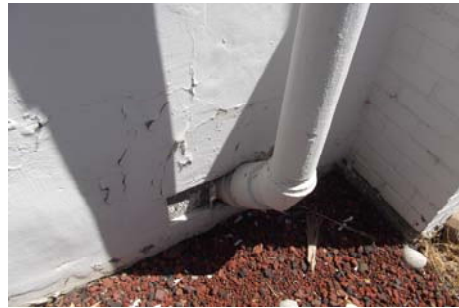
“Asbestos” Like Material, Unused Flue Pipe

- **Repair:** All trash should be removed from the crawl space. Old pipe and miscellaneous material create obstacles for tradesman and is a nuisance.
- **Improve:** Old floor furnace flue pipe exiting crawl space on south side should be removed. Asbestos like material was also observed in this pipe. *The Environmental Protection Agency (E.P.A.) reports that asbestos represents a health hazard if "friable" (damaged, crumbling, or in any state that allows the release of fibers).* An asbestos removal specialist should be engaged for removal of this pipe. Further guidance is available from the Environmental Protection Agency (E.P.A.). There may be other materials within the home that contain asbestos but are not identified by this

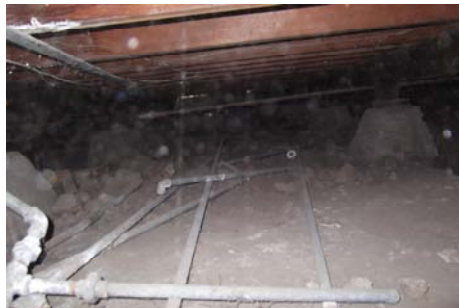
Unused Material

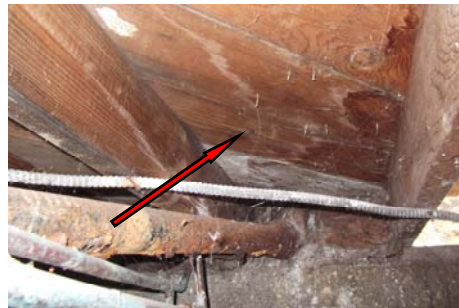
No Insulation Under Floor, Water Damage Observed

- Insulation improvements to the floor above the crawl space may be desirable, depending on the anticipated term of ownership.
- **Improve:** Damaged crawl space wall vent screens should be repaired to keep vermin out.

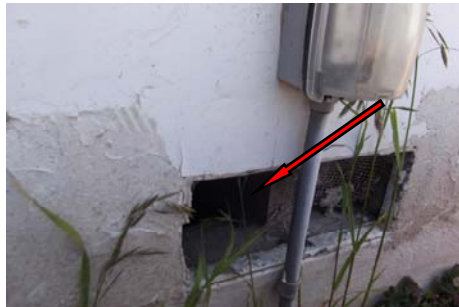
Damaged Vent Screen

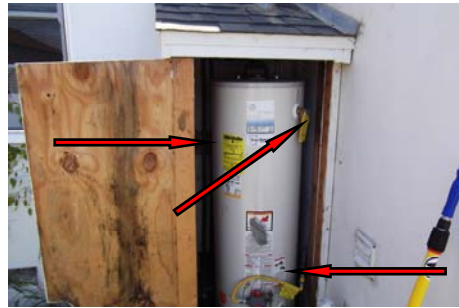
Seismic Straps Needed, Missing TPRV Extension

- **Repair:** The discharge piping serving the Temperature and Pressure Relief (TPR) Valve for the water heater should terminate not less than 6 inches or more than 24 inches above the floor.

- **Repair:** Water heaters in seismic zones should be anchored or strapped to resist movement during earthquake conditions. Recommend installing two straps, one in the top 1/3 of unit and one at least 4 inches above controls. Unit should be unable to move.

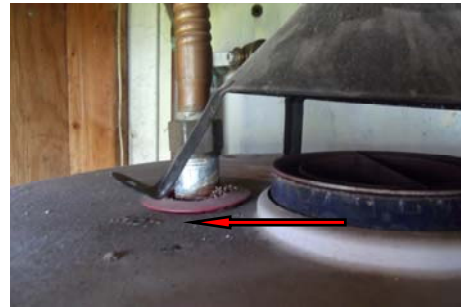
Improper Position Draft Diverter, Exhaust Spill Observed

- **Repair, Safety Issue:** The water heater venting system shows evidence of exhaust “spillage”. *This is a serious condition that could be a health threat to the occupants of the home.* This condition should be addressed promptly.

- **Repair, Safety Issue:** The “draft diverter” of the water heater venting system is configured in such a way that it could allow spillage of exhaust products. *This is a potential safety concern that should be addressed promptly.*

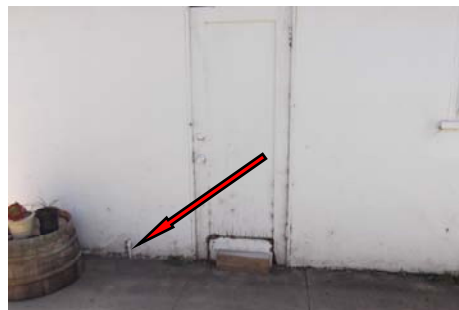
Un-insulated Gas Pipe In Concrete

- **Repair:** The “union” in the gas piping is not suitably located (in crawl space NW corner). Unions in gas piping should only be found at meters and at appliances after the shut off valve.
- **Repair:** A “drip leg” or sediment trap is normally required for water heater connections. Recommend consulting a licensed plumber.
- **Monitor:** It is questionable whether the underground gas piping is suitably protected from corrosion at exterior detached garage location. The gas utility should be consulted.

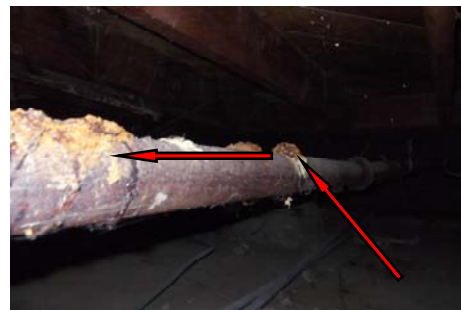
Waste System Deterioration

- **Major Concern, Monitor:** For the most part, the waste piping is old. It may be prone to unexpected problems. Recommend further evaluation of entire drain waste and vent system by a qualified plumbing contractor.
- **Repair:** The waste piping is leaking in multiple locations in crawl space. See above evaluation.
- **Repair:** Unsealed openings in the waste piping should be corrected by a qualified plumber.
- **Repair:** The vent stack that penetrates the roof over bathroom should extend at least 6 inches above the roof and should be at least 2 inches in diameter. Recommend repair of condition(s) noted by qualified plumbing contractor.

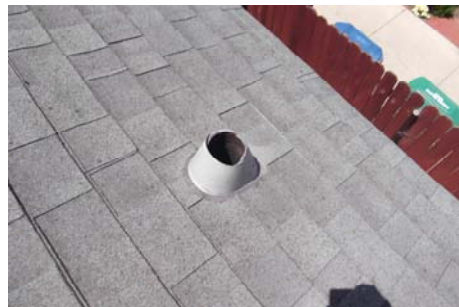
Un-sealed Flashing. Vent Pipe Insufficient Height

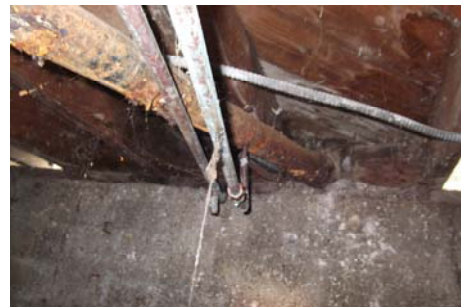
Old Pipe, Substantial Corrosion, Water Damage To Sub-Floor

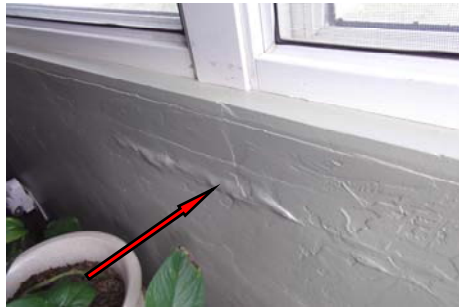
Bulging Plaster

- **Monitor:** The plaster shows evidence of bulging in living room south east corner where repairs are evident on outside. Recommend engaging a qualified general contractor to further evaluate the window assembly.
- **Monitor, Repair:** Abandoned kitchen exhaust hood assembly should be removed or repaired. Recommend engaging a general contractor for removal or repair of condition(s) noted.

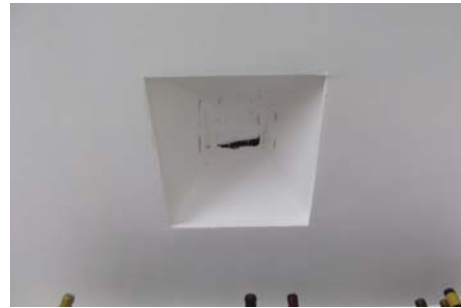
Abandoned Exhaust Vent

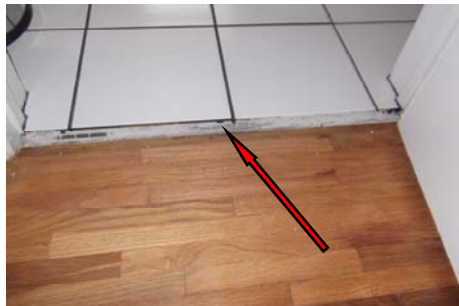
Missing Threshold Piece

- **Repair:** The transition piece is missing at door thresholds in kitchen and bathroom. Recommend repair of condition(s) noted by a qualified flooring contractor.

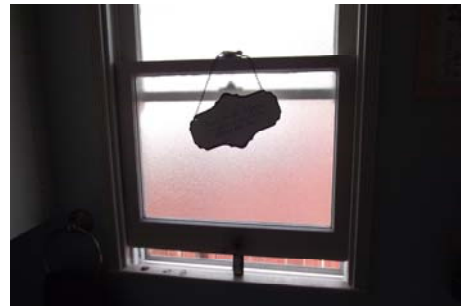
Damaged or Missing Window Weights or Hardware

- **Safety Issue:** The window(s) are painted shut at kitchen south west window. The windows should be operable in case of an emergency. If windows do not move freely once paint seal has been broken we recommend engaging a qualified building contractor to repair condition(s) noted.
- **Repair:** Single hung windows are missing hardware to keep windows in open position at multiple locations around the house. Recommend repair of condition(s) noted by a qualified window contractor.

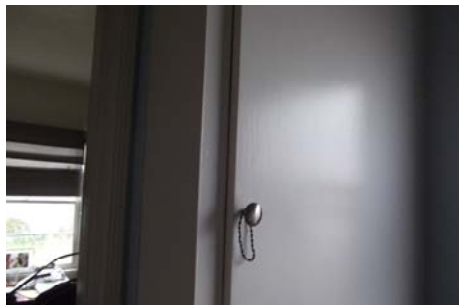
Some Cabinet Doors Won't Shut

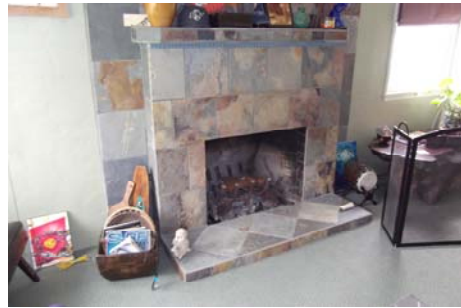
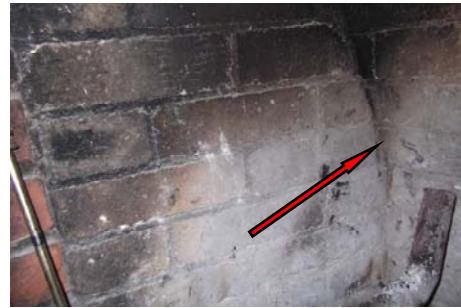
Crack In Left Corner Of Firebox

- **Repair, Safety Issue:** A level 2 inspection of this fireplace should be performed by a FIRE certified Inspector prior to operating.
- **Monitor:** The fireplace shows evidence of having a poor draft. There are a number of improvements that can be undertaken to alter this condition (if it proves to be a problem). Recommend engaging a FIRE certified technician to further evaluate the system.
- **Monitor:** The fireplace firebox mortar should be improved.
- **Repair, Safety Issue:** The rear wall of the fireplace firebox should be repaired by a FIRE certified technician for improved safety.
- **Repair:** The fireplace damper is missing. See above (Inspect) comment.

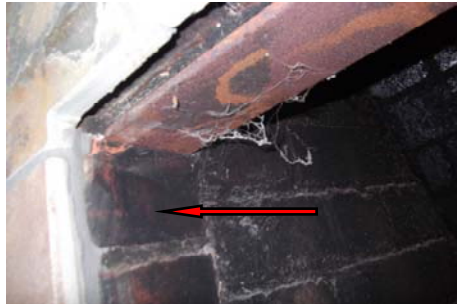
Evidence of Poor Draft

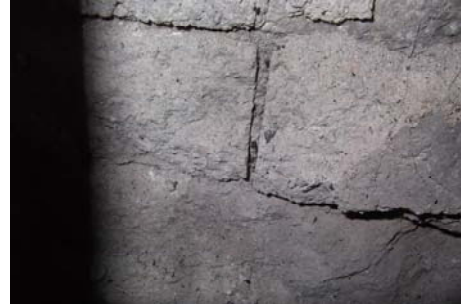
Deteriorating Mortar In Firebox

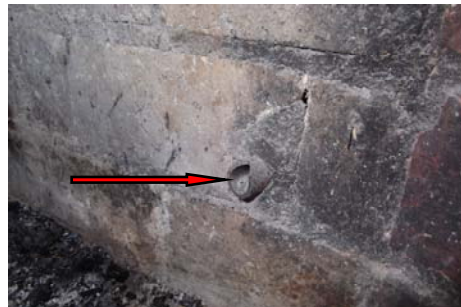
Unsealed Pipe In Firebox

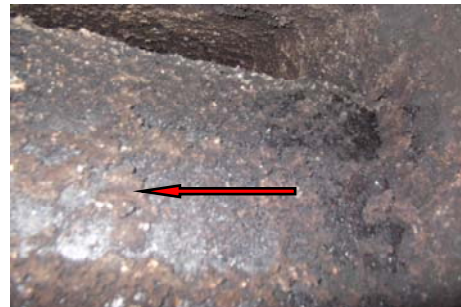
Creosote Buildup

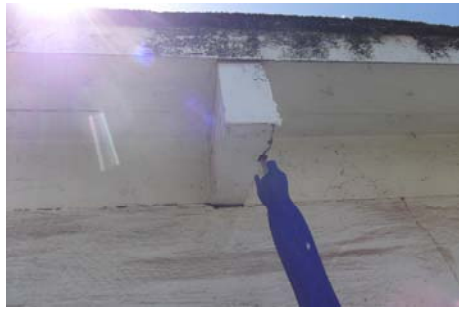
Detached Garage Eave Rot

- **Repair:** The eaves show evidence of rot at multiple locations around garage. Repair or replacement is needed.

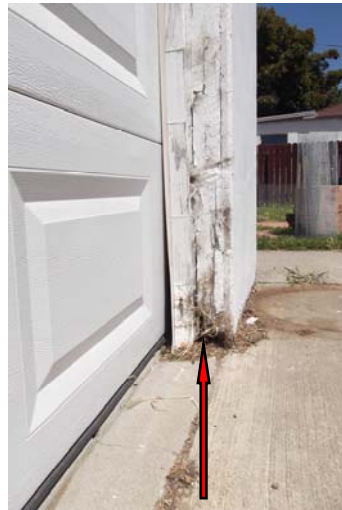
Trim Deterioration

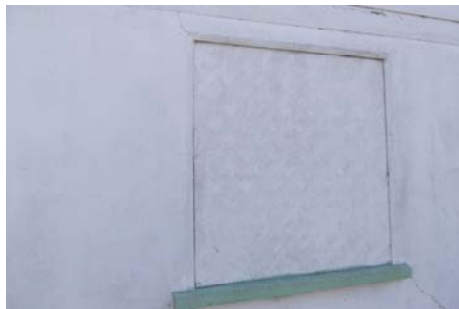
Boarded Up Window

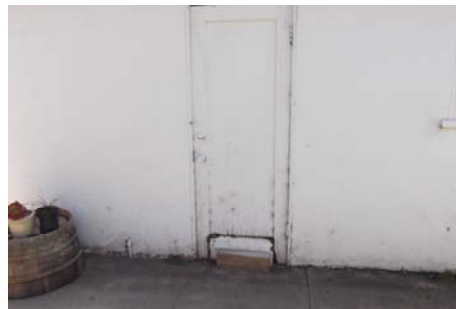
Deteriorated Service Door

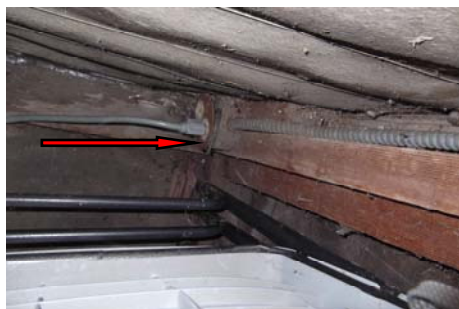
Suspect Garage Electrical

- **Safety Issue:** All junction boxes should be fitted with cover plates, in order to protect the wire connections. (Laundry Room)
- **Repair:** Wiring entering garage is suspect and should be evaluated by a qualified electrical contractor.

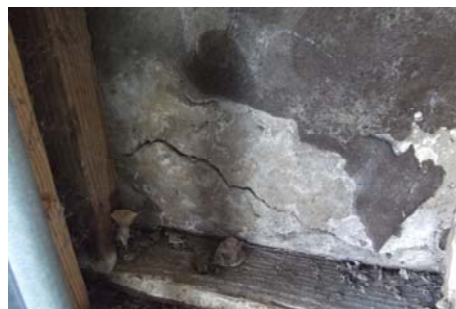
**Deteriorated Garage Stucco and Paper,
Moisture Damage On Sill**
